# STS-114 / LF1 Flight Readiness Review

**Bridget Z. Johnson  
EVA Office  
Johnson Space Center  
June 29, 2005**

# ISS EMU Coolant Loop Recovery

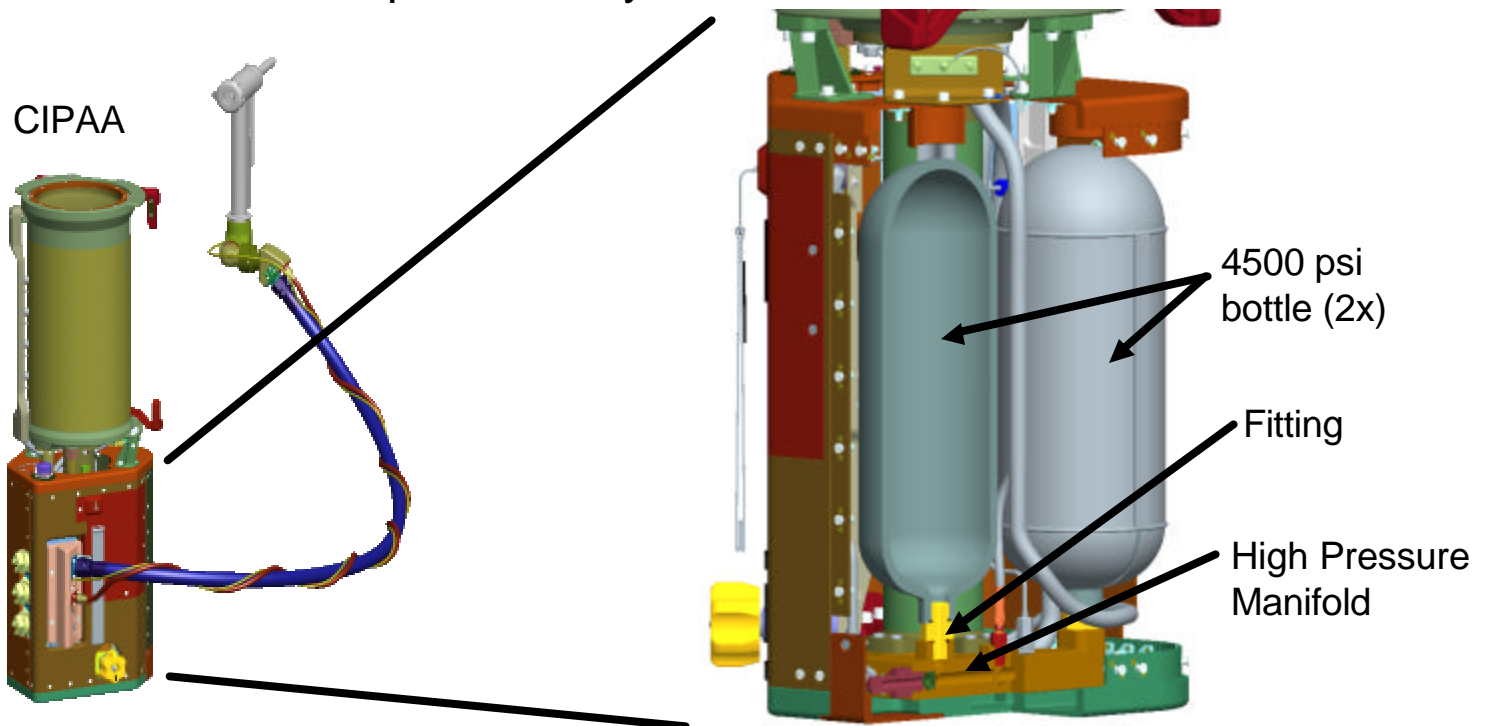
## ❑ CIPAA Qualification unit failed qualification vibration testing on 6/27

- CIPAA depressed on the order of 1000psi per minute
- Post test hardware inspection revealed that one of the two 4500 psi nitrogen bottle fittings had backed out of the high pressure manifold a sufficient distance to depress the system

- Option 1 - Analysis of acceptance and qualification vibration loads test regime and results of tests already completed to evaluate flight hardware acceptability as is for one or more flights
  - ✓ CIPAA hardware failed qualification vibe in the 10<sup>th</sup> minute of the 3<sup>rd</sup> axis (test was 12 minutes each axis)
  - ✓ Vibe length was derived to certify the CIPAA for 25 missions
  - ✓ CIPAA was hard mounted for vibe test, but will be soft stowed for flight
- Option 2 – Add secondary locking feature to maintain preload of high pressure manifold/fitting and fitting/N2 bottle interfaces on the CIPAA qualification unit, redo vibe test and then update the flight units.
  - ✓ Would not impact flight units fill on 6/29
  - ✓ Fix on flight units would need to be in place NLT 7/2 to avoid impact to existing stowage schedule

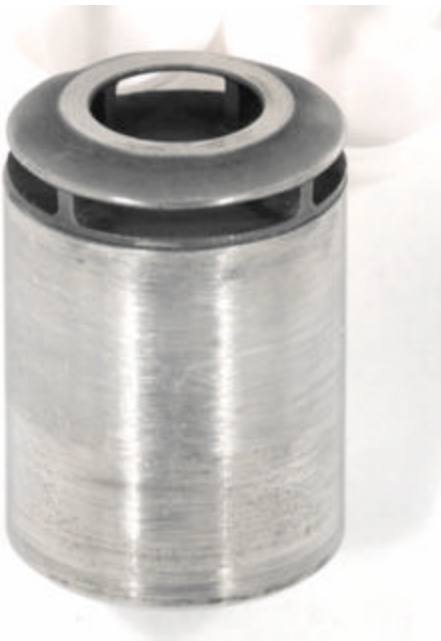
Nickel and biomass fouled  
Rotor was 'gritty' as it was  
rotated in cup

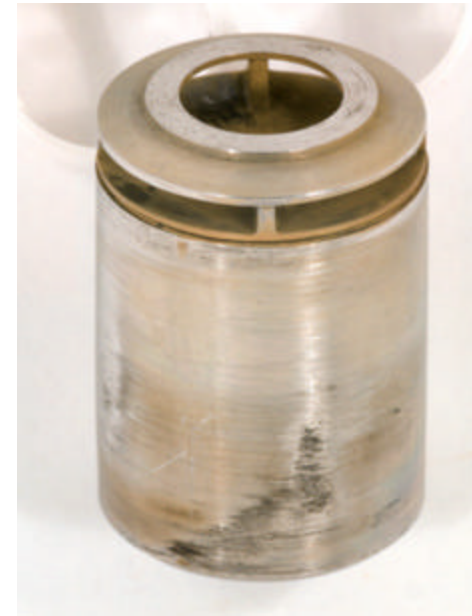
3013

Iron oxide, Nickel and  
biomass fouled  
Rotor was rotational  
'stuck' in cup

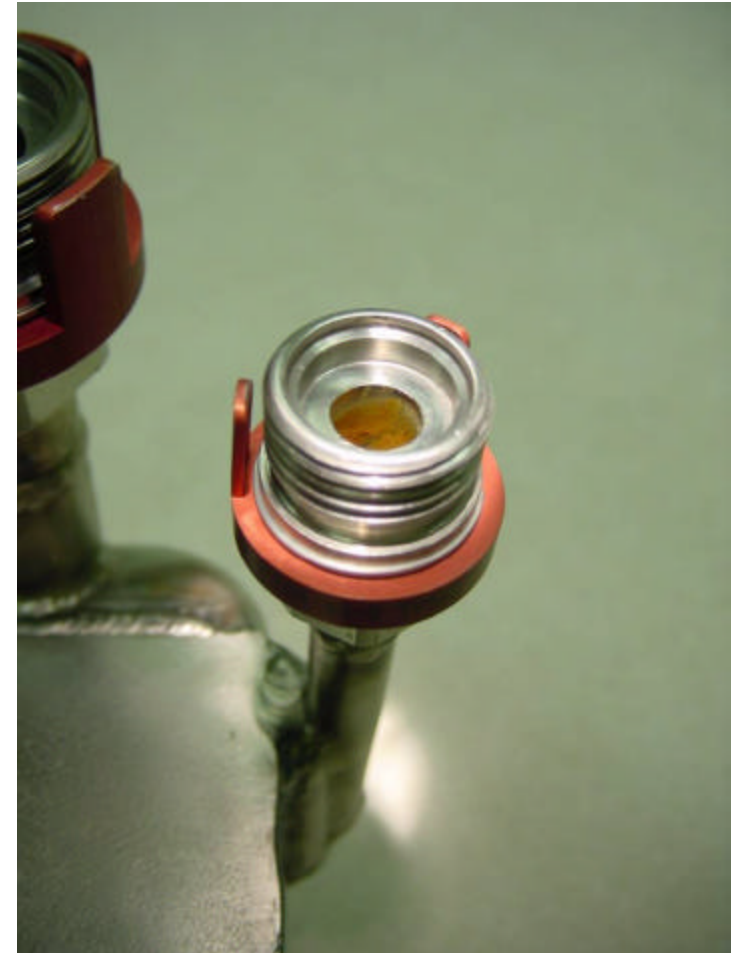
- SPCU Hx Rust
  - SPCU was planned to be changed out in 9/05 due to predicted limited life from single braze
  - Qualification SPCU produced rust from exposure to low pH water which was verified by a second test
  - Flight Spare double brazed SPCU showed no sign of rust from exposure to low pH water
  - Flight Spare SPCU manifested on 17P and successfully replaced during stage

- Flight Spare double brazed SPCU showed no sign of rust from exposure to low pH water
- Flight Spare SPCU manifested on 17P and successfully replaced during stage
- Successfully performed R&R

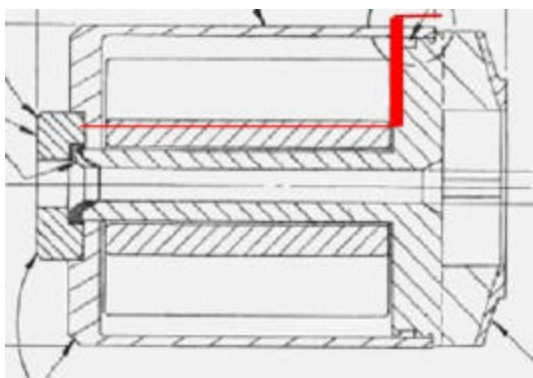
Rotor Assembly

- Bond line between impeller assembly and magnet/cap sub-assembly separated (red-line)
